## WEST SHORELINE DRIVE REALIGNMENT • R-7192 / PW-26-759

# Before the Trees Become Waste

## Protecting the existing mature riverside grove at César E. Chávez Park, north of Ocean Boulevard

West Shoreline Drive Realignment Project • R-7192 / Procurement PW-26-759 • Long Beach, California

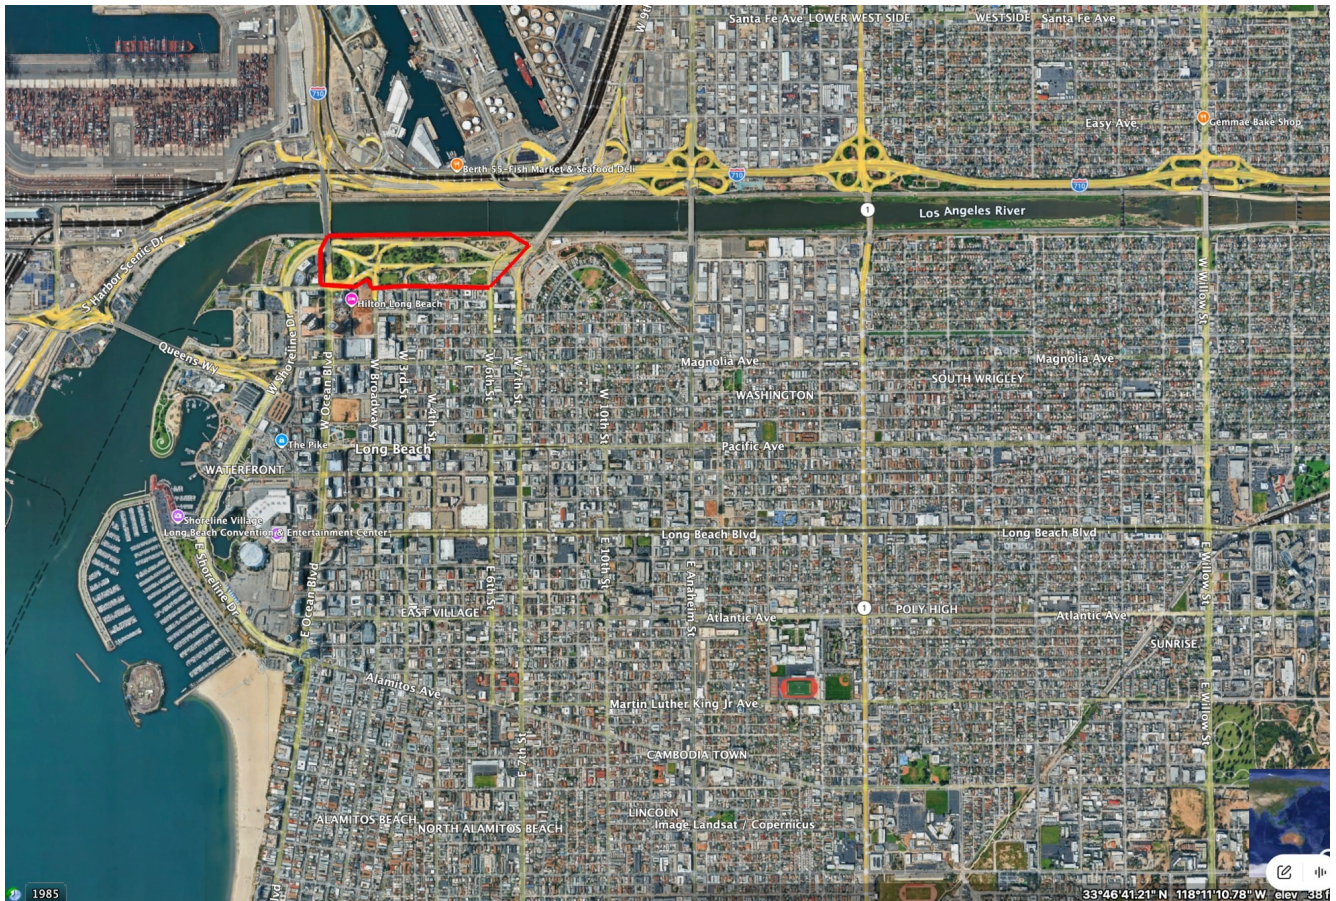
FIGURE 1 · Regional satellite-map screenshot supplied by the investigator, captured 17 Oct 2026. Red polygon is a resident-defined STUDY AREA around the César E. Chávez Park / Los Angeles River grove; it is not an approved construction boundary or a map of authorized removals. Underlying aerial imagery date is unverified. The image illustrates geographic context; citywide park inequities are independently documented in [P02].

The regional aerial shows a conspicuous grove within a landscape of freeways, roads, housing, commercial property and industrial infrastructure. A map alone cannot quantify ecological scarcity; however, the City’s own Open Space and Recreation Element update reports that lower-income neighborhoods have access to 90% less nearby park space than higher-income neighborhoods, and neighborhoods of color have access to 91% less than predominantly white neighborhoods. It identifies especially severe deficits in Central, West and North Long Beach. These are citywide/neighborhood comparisons, not measurements for each tree in the red polygon. [P02]

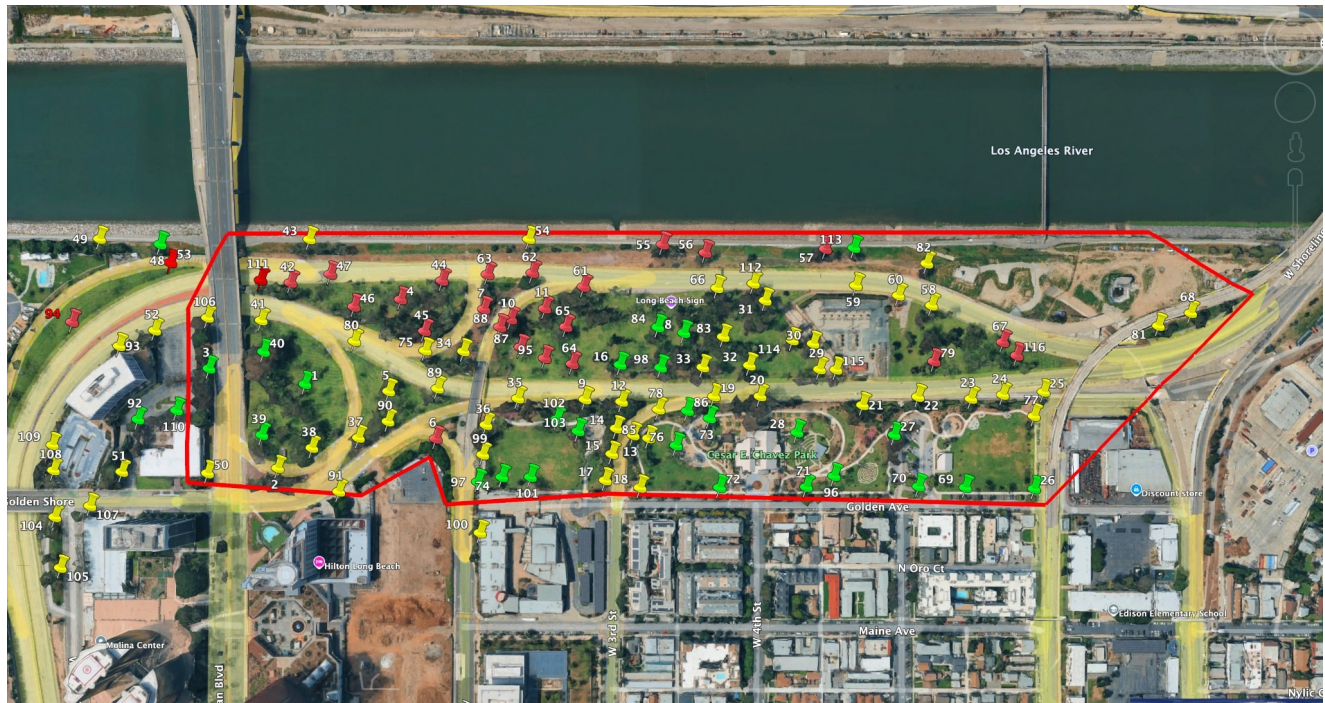
FIGURE 2 · Investigator's numbered field atlas. Red polygon represents the preliminary northern study boundary; colored pins are field-observation categories (red / yellow / green), NOT themselves contractual removal codes, tree-condition diagnoses, or guarantees of protection. Some observations lie outside the polygon. Screenshot supplied 17 Oct 2026. Source: [\[A1\]](#).

Interpretation note: green denotes comparatively lower identified construction concern; yellow denotes possible construction trauma, including near removals, pavement demolition or root-zone work; red denotes apparent direct removal/clearing conflicts from the drawing review. The marker colors are an investigative priority scale, not a health diagnosis and not a construction authorization. At present, even a tree that appears relatively safe can be affected by root disturbance or later plan changes. [\[A1\]](#)

The atlas is intended as an evidence index. Each observation should ultimately be connected to a dated photograph, coordinates, corresponding DEM drawing, original survey identification, proposed disposition, any Engineer-directed change, and observed outcome. A red atlas pin is meaningful evidence of the investigator's recorded conflict assessment, based on DEM review; however, the pin alone does not distinguish an explicit tree-removal annotation from a larger clearing-and-grubbing area. Each observation must retain that evidentiary subtype and a sheet citation before an individual removal designation is claimed.

The 116 geographic observations arose from a DEM-by-DEM geographic comparison using official demolition drawings, roads, the riverbank, bridge columns, structures and matching station references, assisted by Google Earth imagery. All twenty DEM sheets were visually examined. The DEMS screenshot archive contains 64 investigator screenshots organized by engineering sheet; the separate Street View archive contains 381 screenshot images. These are substantial provenance resources, not a surveyed individual-tree census. [\[A1, A4, A5; P05\]](#)
